NASA TN D-8411

EFFECT OF LOW-VELOCITY IMPACT DAMAGE ON THE COMPRESSIVE STRENGTH OF GRAPHITE-EPOXY HAT-STIFFENED PANELS

*Marvin D. Rhodes, Jerry G. Williams,
and James H. Starnes, Jr.*

*Langley Research Center
Hampton, Va. 23665*

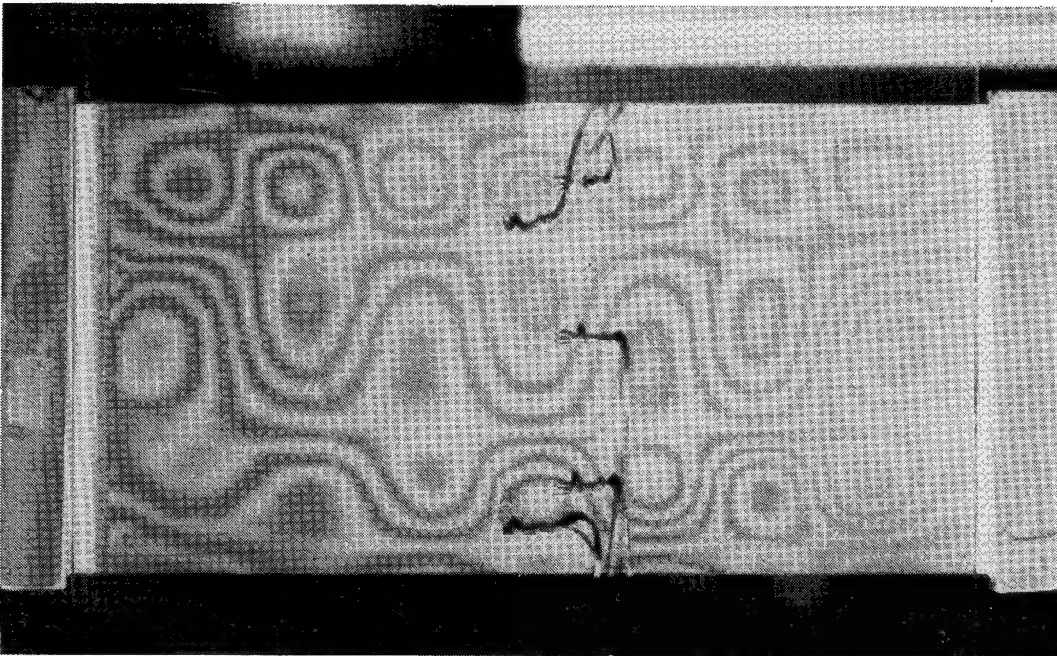
Undamaged panels.— Three panels of design A and four of design B were tested in the undamaged condition to evaluate panel behavior due to applied axial compressive load. The response of each panel to the indicated applied load, or strain, is presented in table II. The design A panels buckled near the design strain of 0.0034 and exhibited postbuckling behavior. The design B panels exhibited strength failure near the design strain of 0.0080 prior to buckling. Photographs of a typical normal displacement field as indicated by the moiré-fringe pattern for both design configurations are shown in figure 3. Test panel A1 (fig. 3(a)) has a fully developed buckle pattern at an imposed strain of 0.0036. Test panel B2 (fig. 3(b)) is shown at an imposed axial strain of 0.0079 which is near the strain at which the panel exhibited failure. The pattern seen at the ends of the panel is the result of in-plane restraints imposed by the flat-end test condition (ref. 2).

(a) Panel A1 designed for strain of 0.0034
loaded to strain of 0.0036.

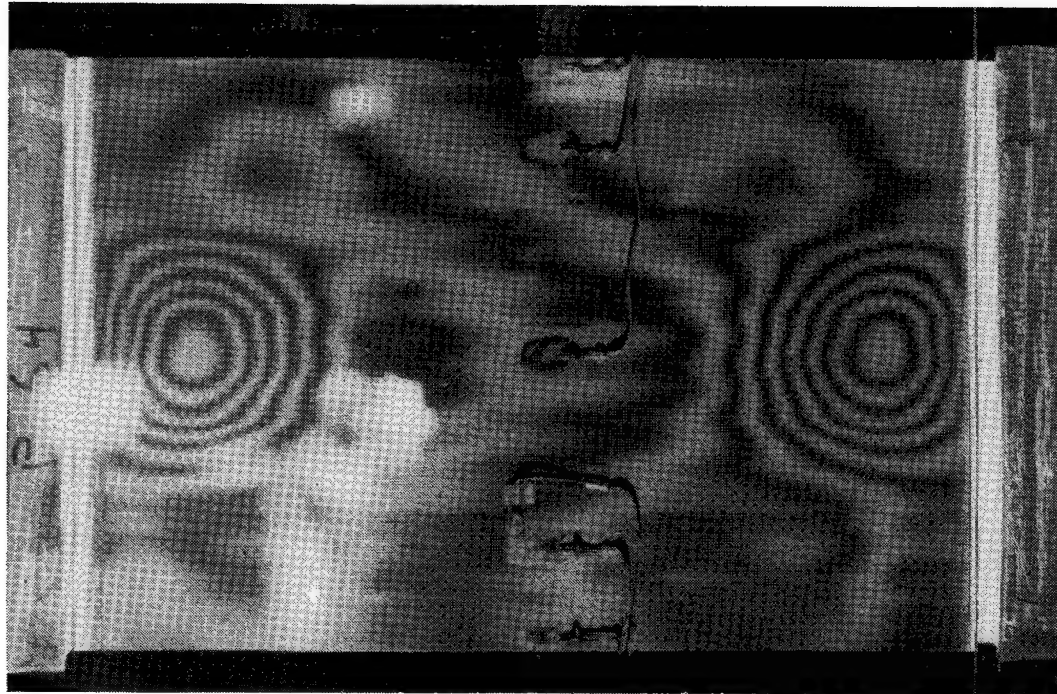
(b) Panel B2 designed for strain of 0.0080
loaded to strain of 0.0079.

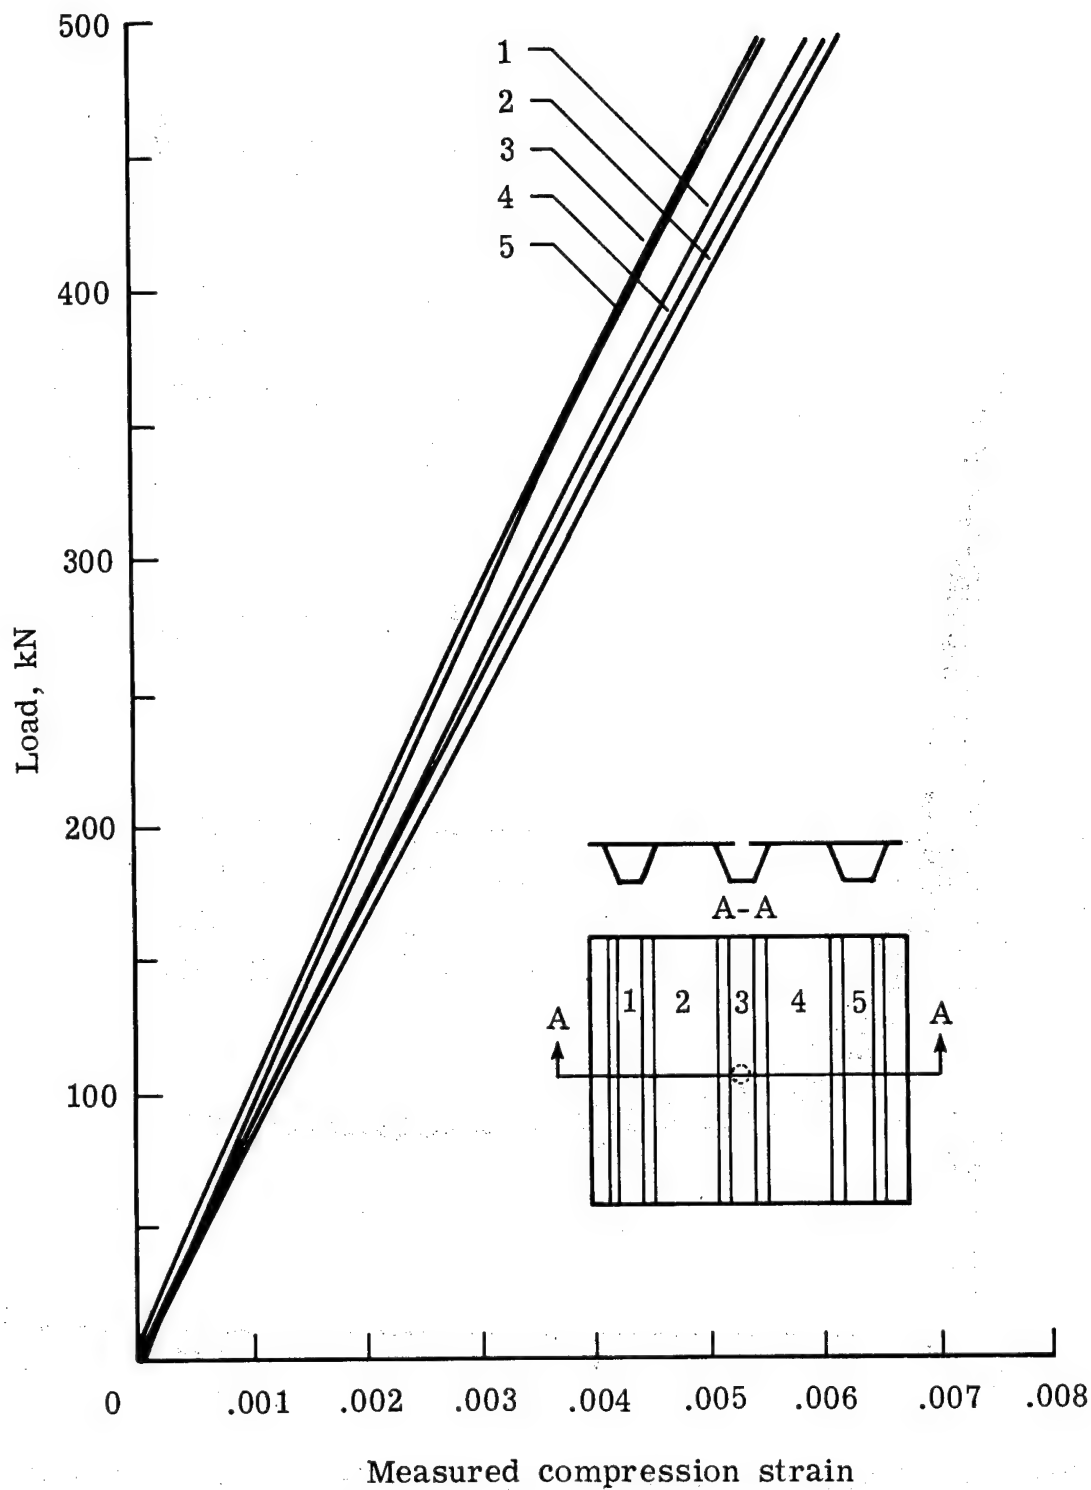
Panel with a cutout.— Panel B5 with the 1.27-cm-diameter cutout was loaded to failure in axial compression. Far-field axial strains were measured during the test by five strain gages located on a line across the panel, 6.35 cm from the cutout center. The locations of those gages and the strains as a function of load are shown in figure 4. These data indicate a nearly uniform far-field axial strain distribution across the panel and a linear load-strain relationship to failure. The average of these gages is referred to in this paper as the applied strain. Panel failure occurred at an applied strain of 0.0058 (applied load of 496 kN) which is 73 percent of the 0.0080 design strain.

Figure 4.- Compression load-strain curves at five locations across panel B5 which has 1.27-cm-diameter cutout in high-axial-stiffness region of center stiffener.

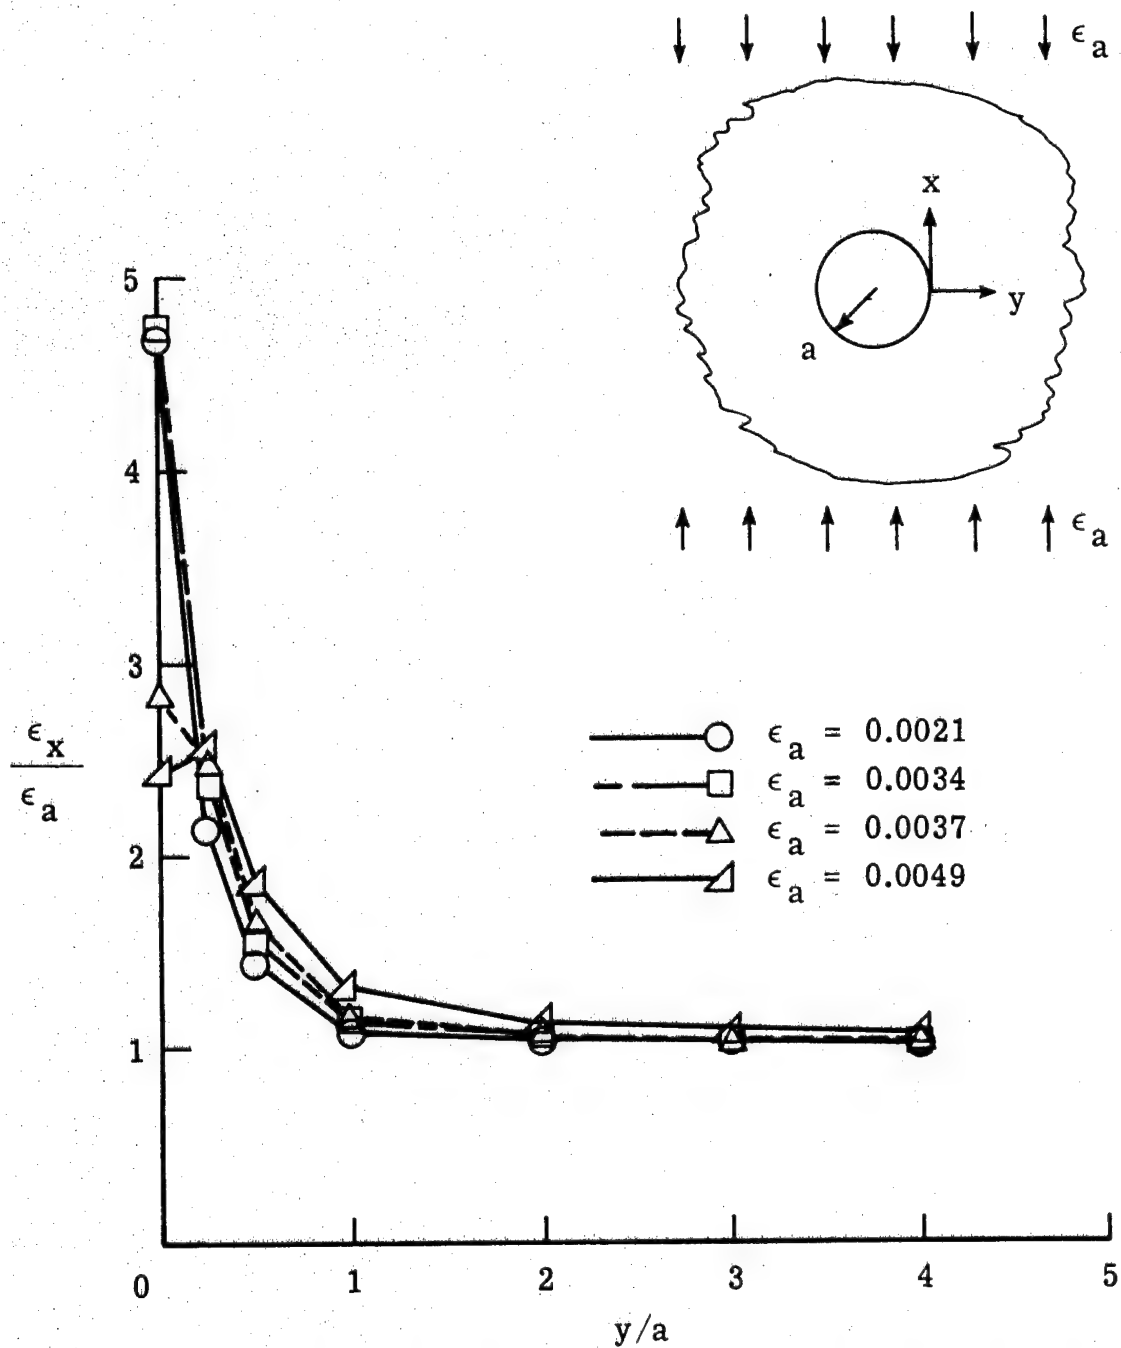
cutout and one gage was located on the cutout free-edge surface. The distribution of strain as determined by these gages across the right side of the panel normalized by the applied strain is shown in figure 5. The strains are several times greater near the cutout edge than those 3 cutout radii away and there are steep strain gradients near the cutout edge. Up to an applied strain of about 0.0034 the strain at the cutout edge is approximately 4.6 times greater than the far-field strain. At an applied strain of 0.0034 the strain at the cutout edge was initially 0.016 and then dropped suddenly to 0.012. It is suspected that a local material failure occurred at this very high strain level. At applied strains between 0.0034 and 0.0049 the strains at the cutout edge were only 2.4 to 2.8 times as great as the far-field strains as indicated by the results shown in figure 5.

Figure 5.- Strain measured in vicinity of 1.27-cm-diameter cutout on panel B5 (ϵ_x denotes measured strain at indicated location at applied axial strain ϵ_a).

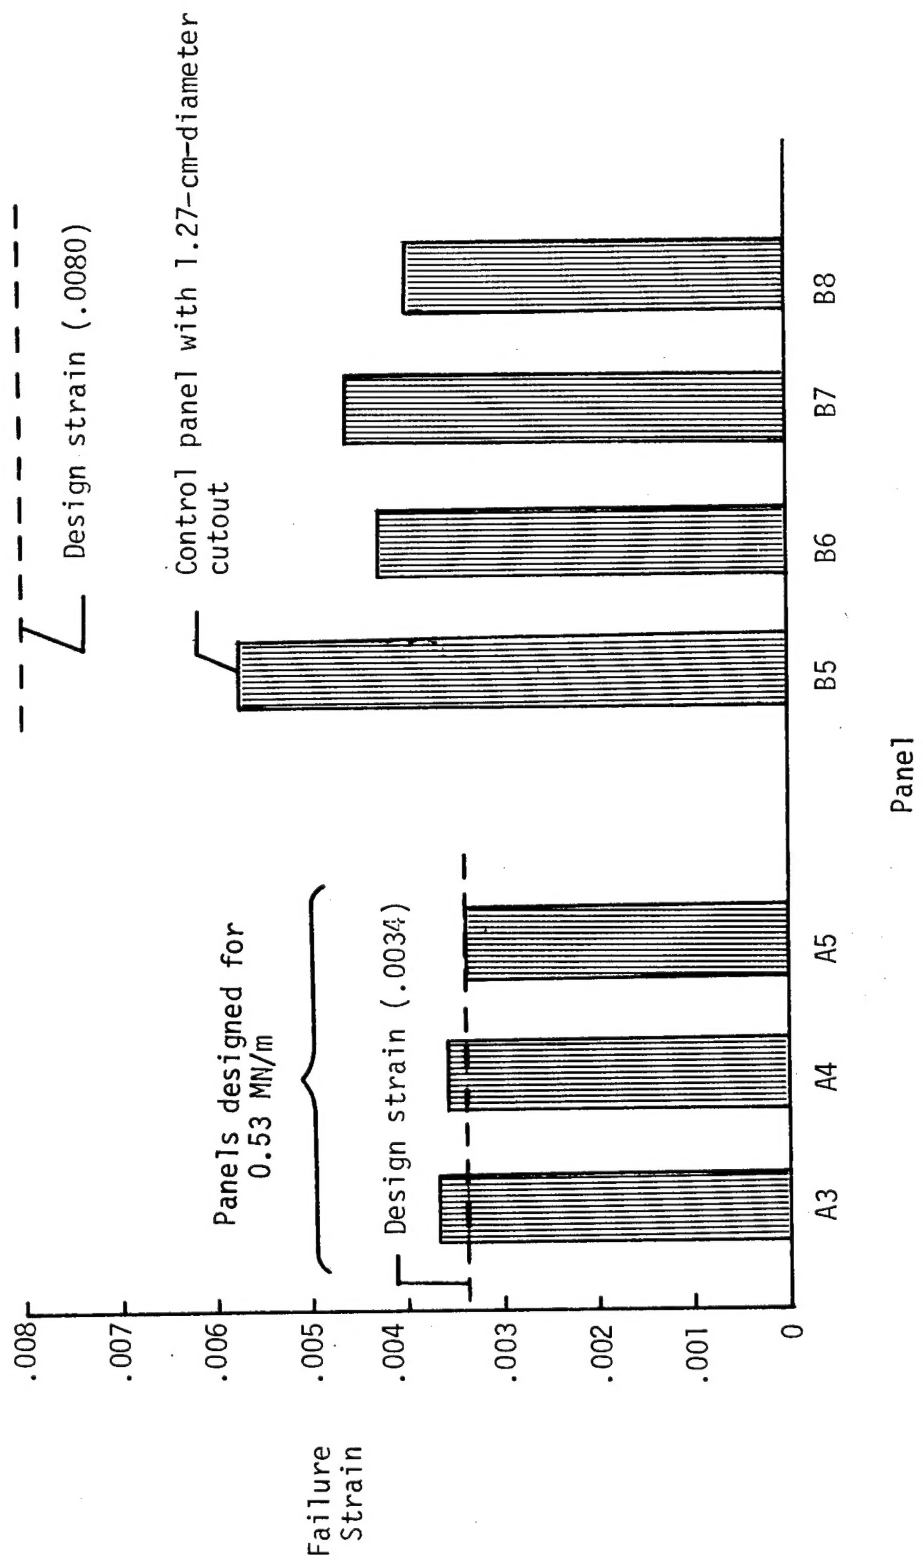
Impact-damage characterization: A comparison of test results for impact damage in the high-axial-stiffness region indicates both similarities and differences in the results for panels of design A and design B. The extent of local damage induced by impact increased with the magnitude of applied axial-compression strain for both designs. The design A panels satisfied the design-strain requirements with the presence of impact damage and also exhibited post-buckling behavior. The design B panels, however, failed due to impact damage at applied axial strains between 50 and 58 percent of the design strain level. Failure strains for impact-damaged panels and the control panel with circular cutout can be compared in figure 12. Limited local impact damage that was not noticeable by visual inspection (panel B6) reduced the ultimate strength of the design B panels as much as extensive visible localized damage (panel B7). All three of the design B panels damaged by impact failed at lower applied strain levels than the control test panel with the 1.27-cm-diameter cutout. The damaged region caused by impact, however, was larger than the cutout. For all design B panels the damage in the high-axial-stiffness region precipitated failure at an applied strain well below the design strain level.

Figure 12.- Failure strains for panels damaged by impact in high-axial-stiffness region and for control panel.
